Manhole Inspection Summary

Manhole # S35Q__060MH

Insp Date: **2/6/09 11:23 AM**

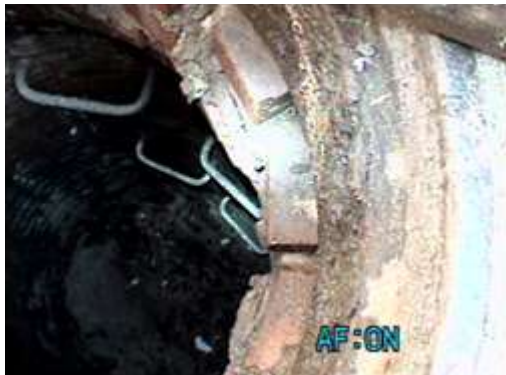
Defect 4

Offset: **2** (in.)

offset

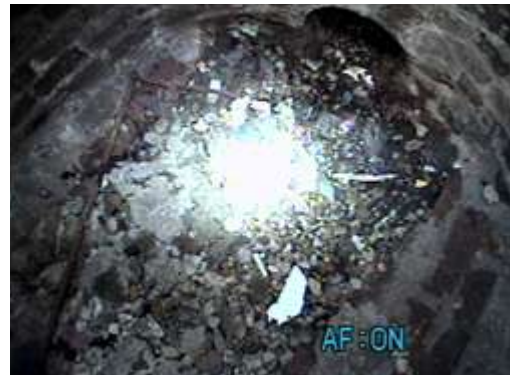
Defect 3

Condition: ☐ Sound ☐ Cracked ☐ Root Intrusion ☐ Deteriorated ☐ Leaks ☒ **Debris**

channel debris

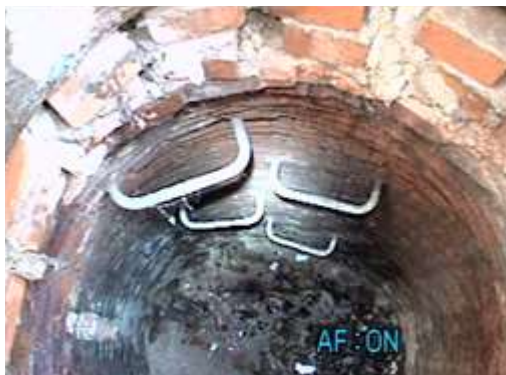
Defect 2

Count: **4** Missing: **0** ☒ **Corroded**

corr steps

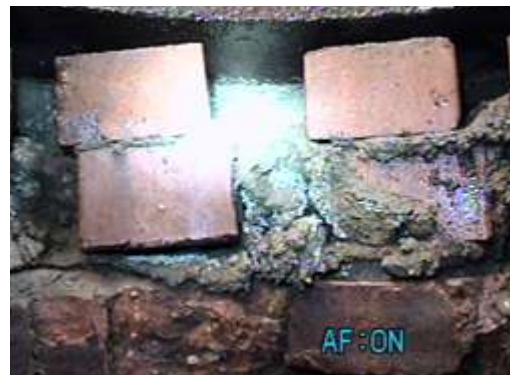
Defect 1

Condition: ☐ Sound ☒ **Cracked** ☐ Root Intrusion ☒ **Loose Brick** ☒ **Deteriorated**

chimney loose bricks, frame adj
